# Hurricane Ian Study

Jim LaDue

Acting Director, NWIRP

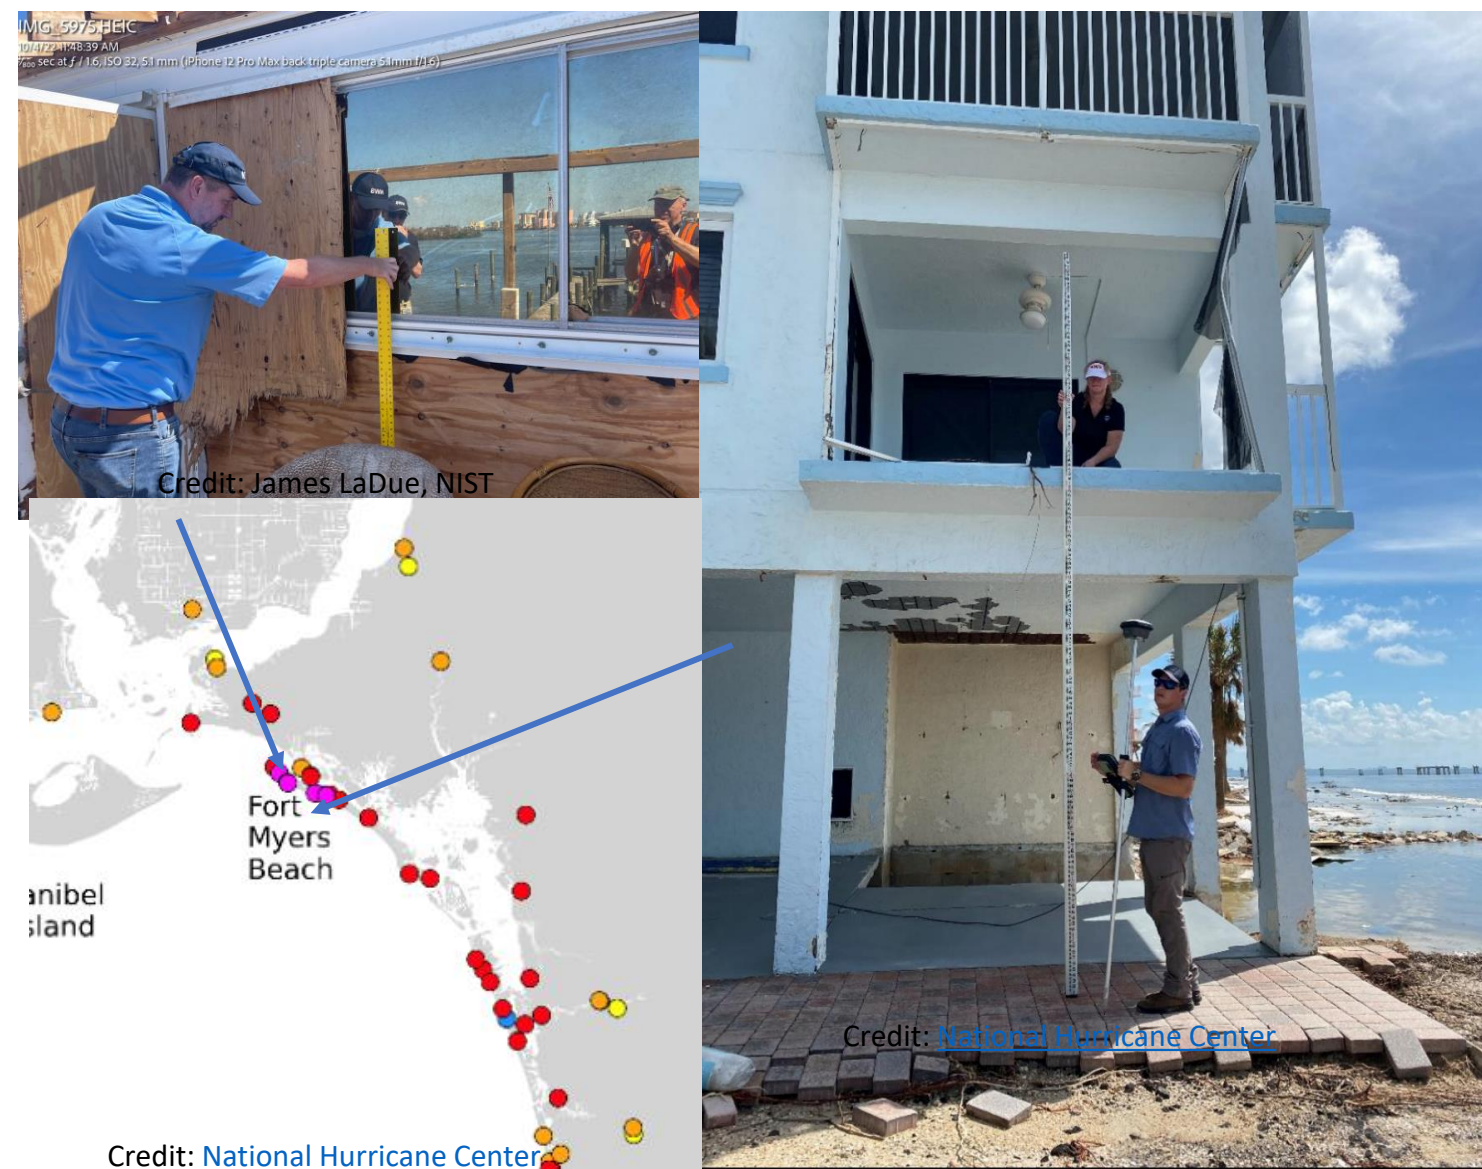
- Related to the most measured impact forcing – buoyancy
- Exceeded return intervals.
- Extensive guidance available in ASCE7.

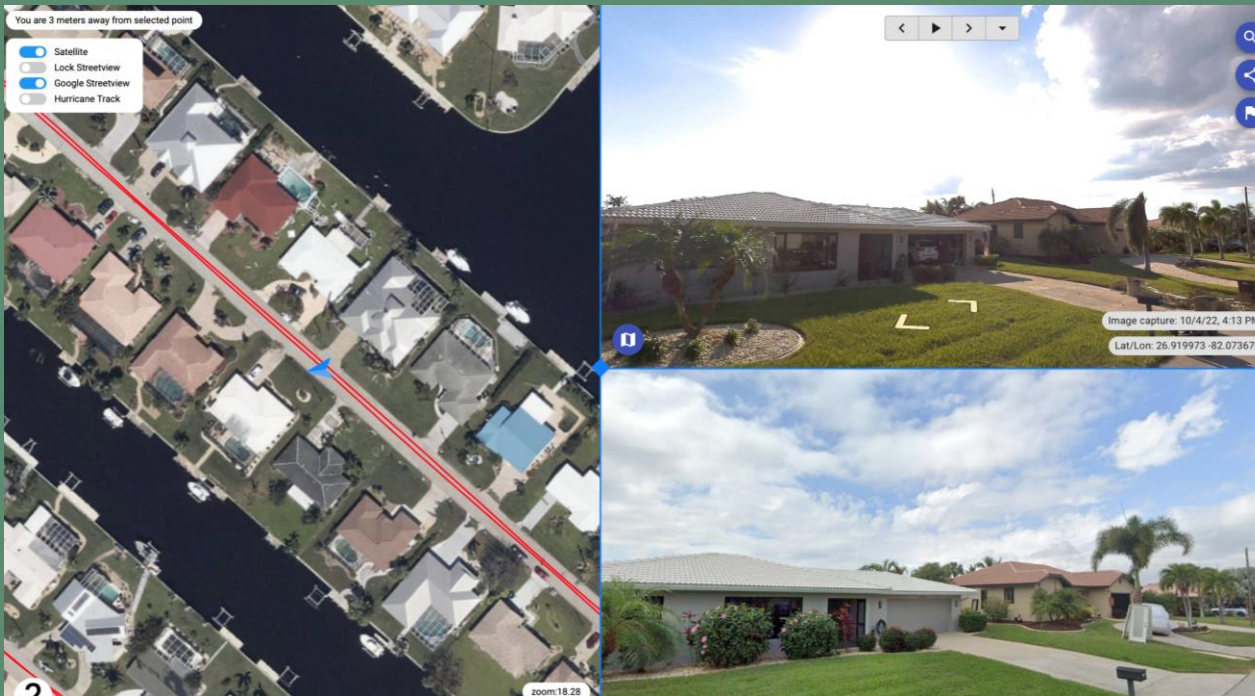
- Peak wind gusts ~125 mph, were ~25 mph below design levels.
- New housing, built to modern codes, had little visible wind damage.

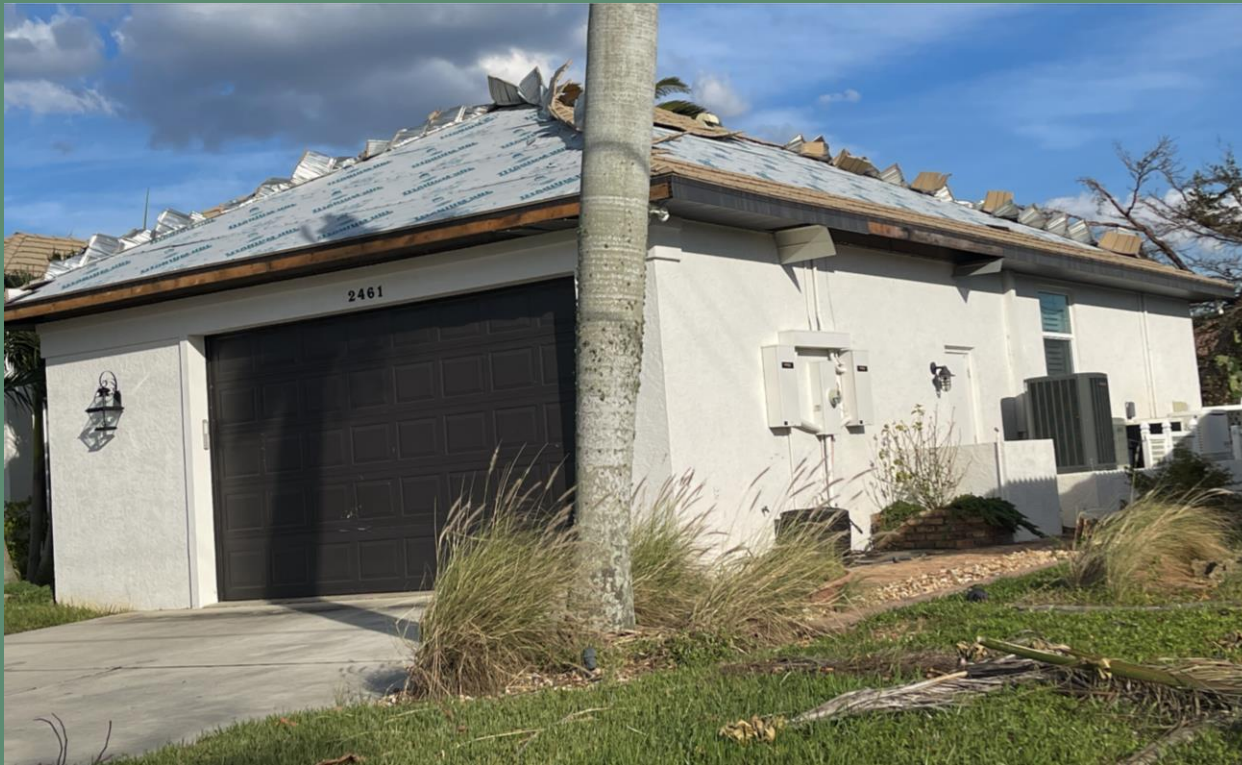
Aluminum roof shingle damage in western Punta Gorda.

- Some residences suffered more significant roof damage.
- Possible causes:
  - Built to older codes
  - Poor application of modern codes
  - Poor maintenance

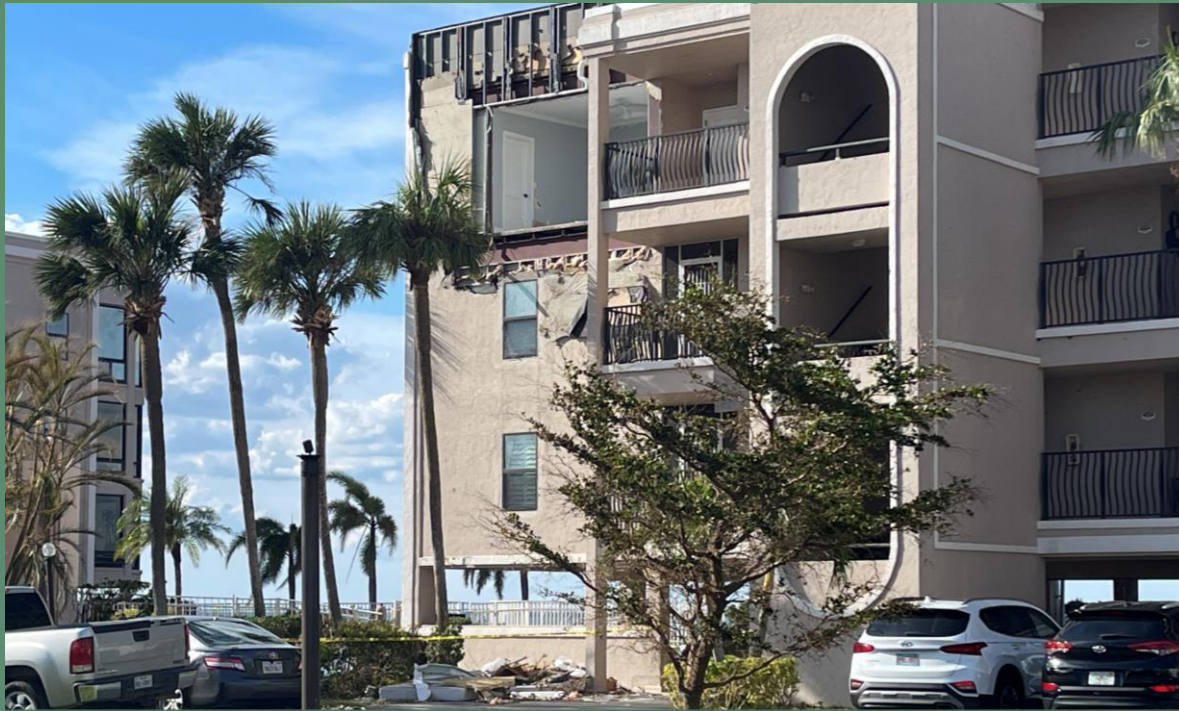
- Blown out window caused collateral damage to siding.

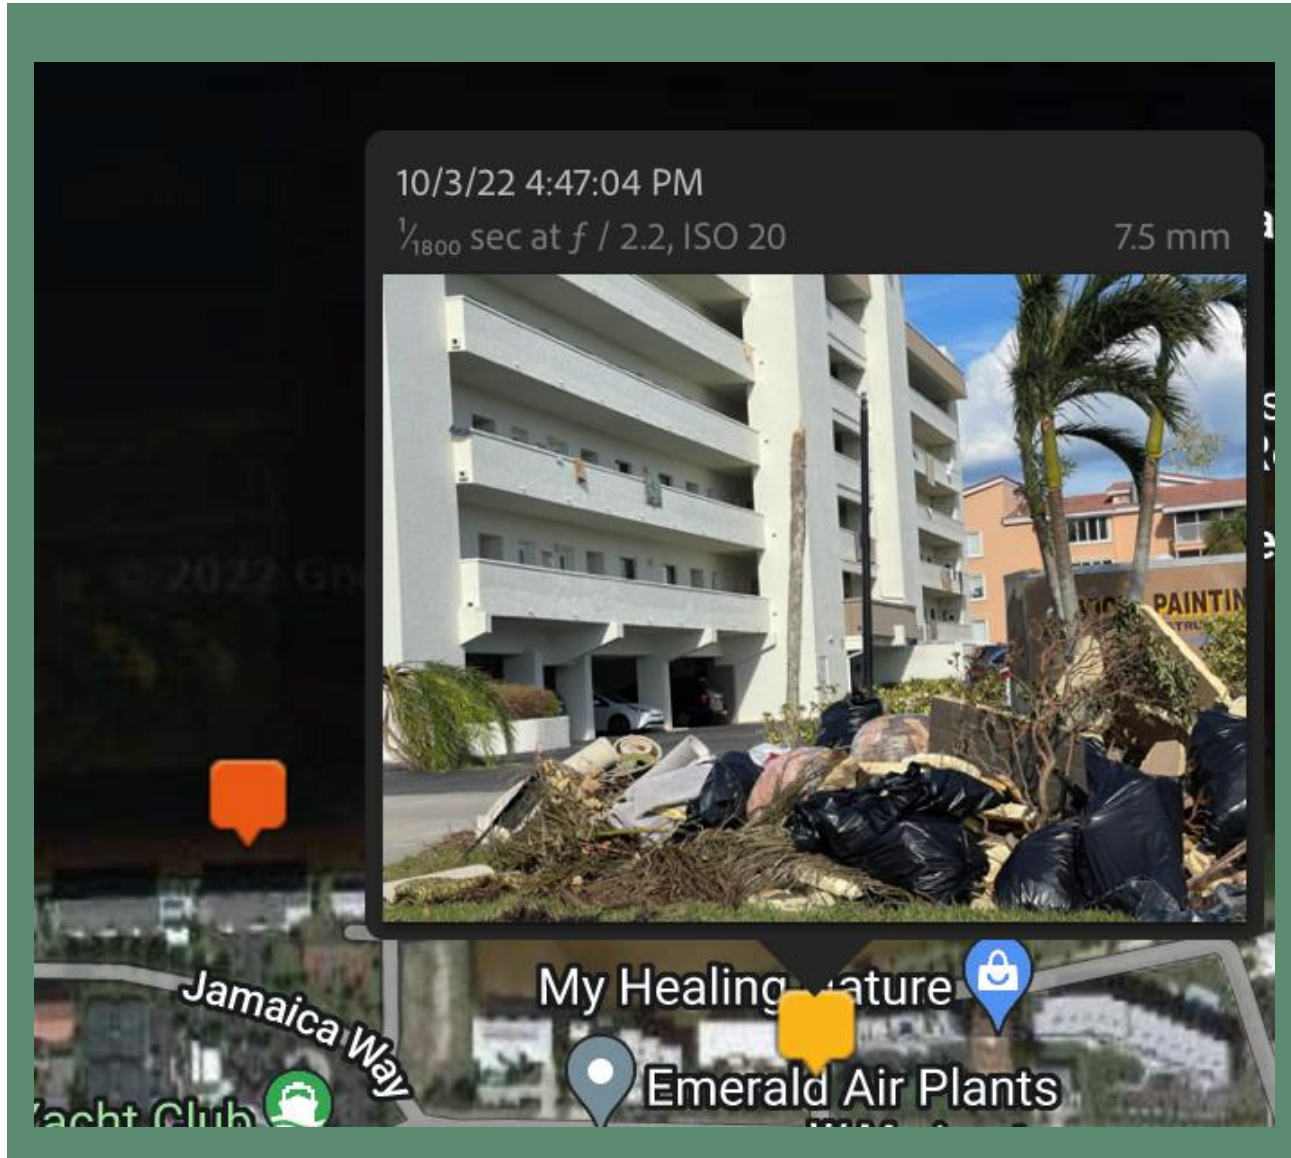
- Wind-induced rainwater intrusion damaged interiors content and finishes.
- Some building systems have little guidance for mitigating rainwater intrusion.
